Project 82880.00
3 December 2021
R.033.Rev0
MJH:bjk

Routine Water Monitoring - September 2021
EBH Waste Processing Facility
60 Donaldson Street, Wyong

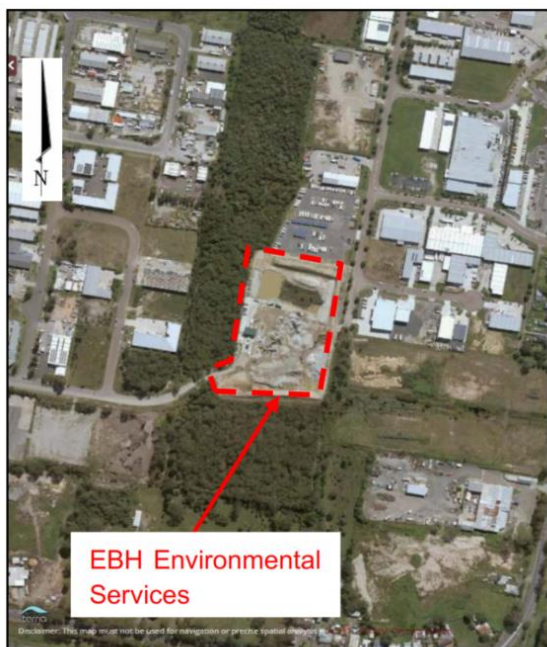
Figure 1: Site Locality

It is understood that the on-site sedimentation pond collects stormwater and general site run-off which discharges toward the western boundary of the site (refer to Figure 1). Monitoring was undertaken to assess the water quality of the sedimentation pond and at the point of discharge. It should be noted that the water was not discharging from the pond at the time of monitoring (21 September 2021).

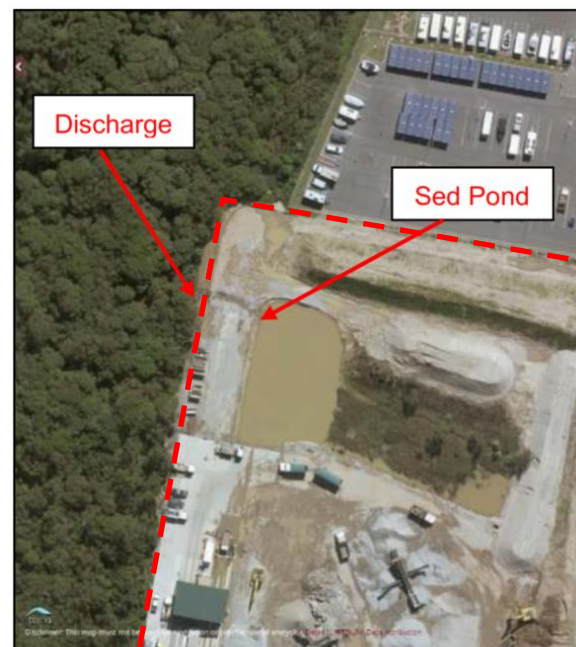
Figure 2: Monitoring locations

The approximate monitoring locations are identified in Figures 1 and 2.

The field work was undertaken on 21 September 2021 by Mr Brent Kerry (Douglas Partners). Visual inspection did not identify any obvious signs of potential contamination on the water surface. No water was observed to be discharging from the sediment pond through a rubble filled trench at the time of the sampling.
